# Excessive wheel flange runout can lead to brake pulsation

TT 10-003

March 2010

## Technical tip

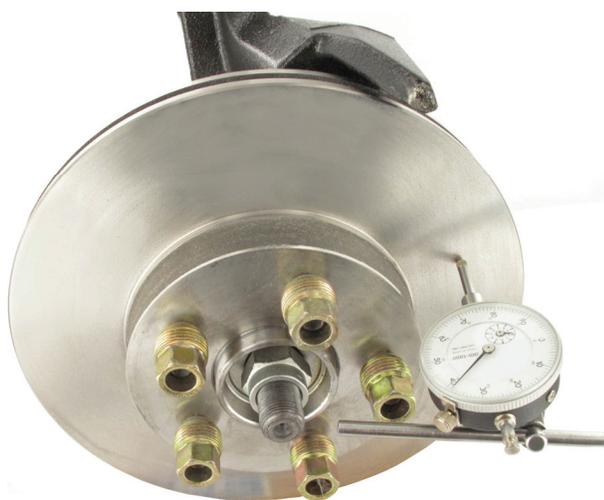
*Fig. 1 Rotor runout*

Because the components of the vehicle work together, a poorly manufactured hub assembly could be the cause of the DTV. Rotor runout measurements and wheel flange runout should be checked to insure the quality of both components. See Fig 1 and 2. The rotor runout relies on the interface of the rotor and hub assembly. Typical rotor runout, as measured

with the rotor mounted on the hub unit, should not exceed 80 microns. Some value line hubs can reach or exceed this limit just on the flange face itself, not considering the contribution to runout that also comes from the rotor. Therefore brake disc runout on assemblies utilizing value line hubs may be up to 5 times the recommended maximum when they are brand new! You may also have to spend additional time indexing the hub and rotor trying to eliminate DTV.

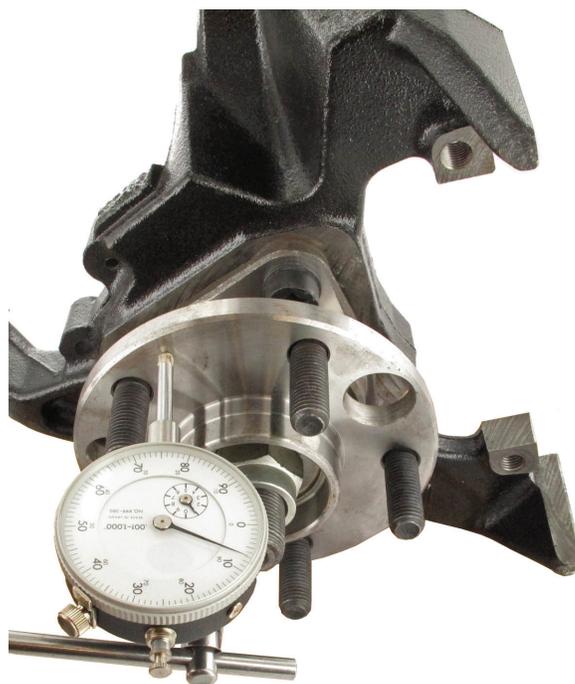
*Fig. 2 Wheel flange runout*

A familiar occurrence is the development of brake disc thickness variation (DTV) over time. DTV is caused by uneven wear of the brake rotor around the pad contact faces. The development of this uneven wear is strongly influenced by the runout of the brake rotor, which in turn is primarily defined by the runout of the hub flange face that mounts to the rotor. If the wheel hub unit runout is high, brake rotor DTV happens quickly. Once this variation reaches 20 microns or more brake pulsation or judder occurs when the brakes are applied. Brake pulsation is easily perceived by the vehicle driver and is the primary source of customer dissatisfaction with brake system performance. If not corrected this can lead to reduced brake system performance and can cause excessive pressure on the hub assembly and lead to premature failure. Even if no immediate failure is noticed for the wheel hub assembly or other braking components the wheel flange runout should be checked.

SKF hub assemblies provide the tightest lateral runout in the market to eliminate any concern with DTV. Choosing premium parts provide the safest choice for your vehicle.
