Brake Job Preemptive Diagnostics

Reprinted from the October 2011 issue of BRAKE & FRONT END

Preemptive Diagnostics

Solving Pulsation Complaints **Before** They Happen

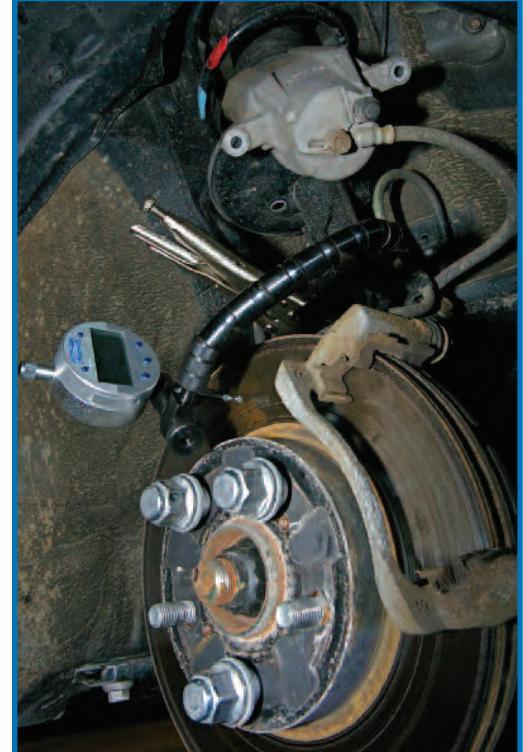
The main culprit of the chronic pulsation was variations in disc thickness or parallelism. The two friction surfaces of a rotor are designed to be parallel to one another within a certain specification. The allowable tolerance is known as parallelism. It is also known as the rotor's disc thickness variation or DTV. In order for the

pad to stay in contact with the rotor, the piston must extend or be pushed back into the housing as force is applied. This creates the pulsation in the pedal that is most noticeable to the driver.

Every time the low spot passes by the caliper, hydraulic pressure at the caliper drops. This produces less braking force as this area passes by the pads. This can also affect braking distances.

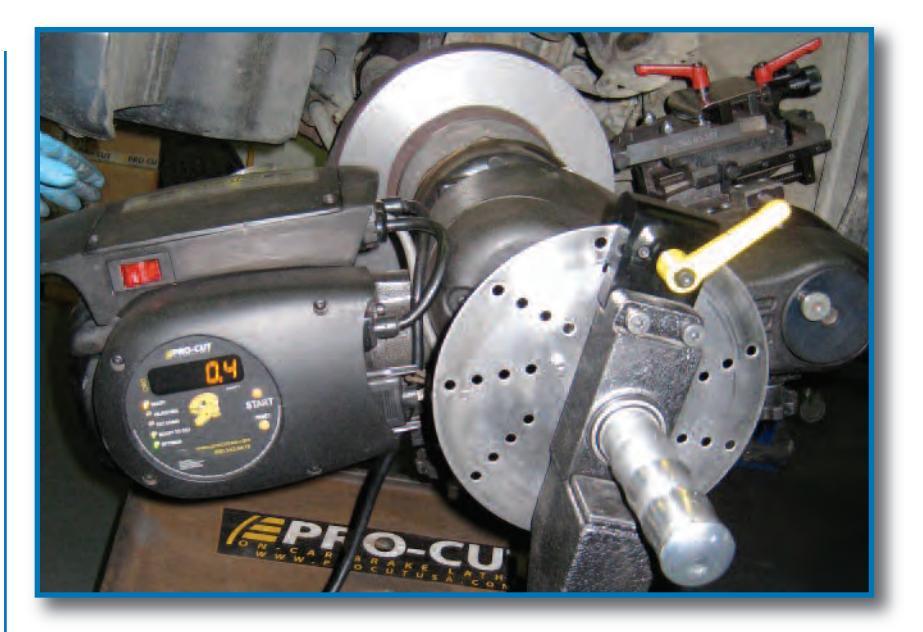
Runout is defined as the amount of lateral (side-to-side) movement of the rotor as it rotates 360 degrees. The specification is usually provided as "TIR" or "Total Indicated Runout." TIR is defined as the runout measured on the vehicle or installed runout. TIR includes all factors that can influence the amount of runout. Runout can be in the hub's flange, the rotor or it can be caused by improper lug torque.

You could also call TIR the stacked runout of the hub/rotor/wheel assembly. All of the above factors add up to give the rotor's TIR. This brings up an important point. The average allowable TIR specification for late-model vehicles is between .001" and .003". This is the maximum allowed! Some manufacturers have specified .000" of runout.

Runout will NOT cause pedal pulsation on vehicles with floating or sliding calipers and the caliper housing is free to move and the runout is not excessive.

Under these conditions, the caliper will "follow" the runout. The caliper housing will move in and out in relation to the runout. This movement will not cause the caliper piston to move. This is a key point to understand. No piston movement results in no fluid movement in the hydraulic system. If there is no fluid movement, the brake pedal won't move or pulsate. So, a key point to understand is runout generally does NOT cause pulsation. Runout causes thickness variation that leads to pulsation problems.
